Lasers in Manufacturing Conference 2025

Applying laser welding in power plant part repair

Workshop and Spare Parts Division, Electricity Generating Authority of Thailand, 25 Moo 8, Soi K.M.10, Kokfad, Nongchok, Bangkok 10530 Thailand

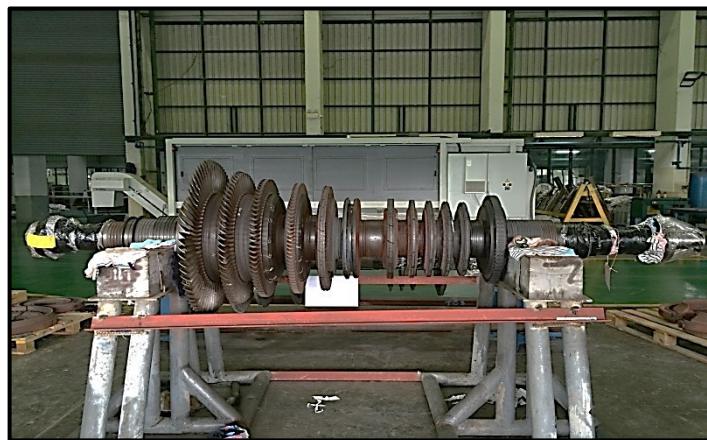
The steam turbine rotor in Fig. 1. having capacity output of 10.4 MW weighing 1,900 kg was deteriorated and transported from power plant to EGAT Workshop in Thailand for refurbishment. From incoming inspections, the rotor material was examined as a low alloy steel with 2.25% Cr and 1% Mo by material identification equipment. Cracks were found by liquid penetrant test on the outer axial surface of the rotor disk as shown in Fig. 2. due to heavy rubbing from stationary components. Microstructural analysis in Fig. 3. was performed using replica technique and revealed a martensitic structure with intergranular cracking on the damaged areas by the microscope with 200X and 800X magnification. This occurred due to rubbing, which generated high stress and overheating, leading to the change of microstructure and consequently cracks on the rotor disk surface.

Fig. 1. Rotor having capacity of 10.4 MW

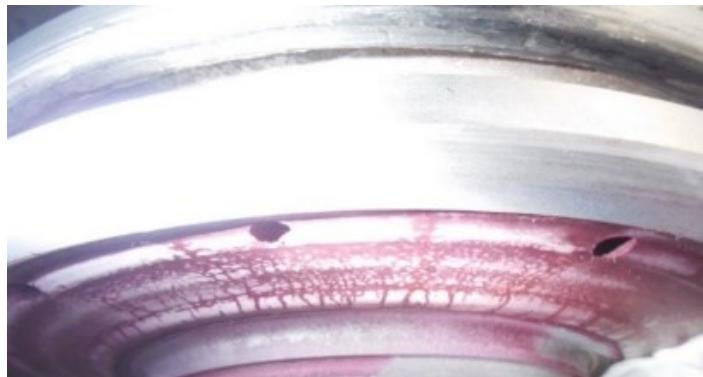
Fig. 2. Cracks on the rotor disk surface examined by liquid penetrant test

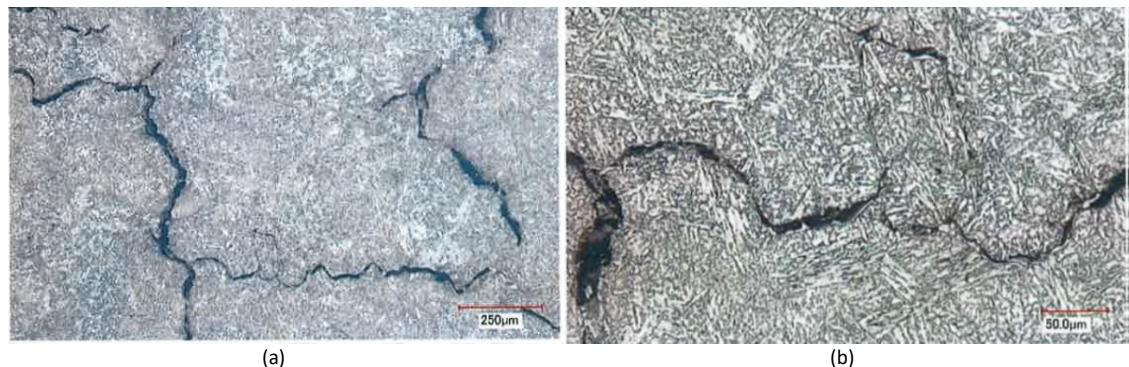
Fig. 3. Microstructure of damaged areas on the rotor disk (a) Magnification 200X; (b) Magnification 800X

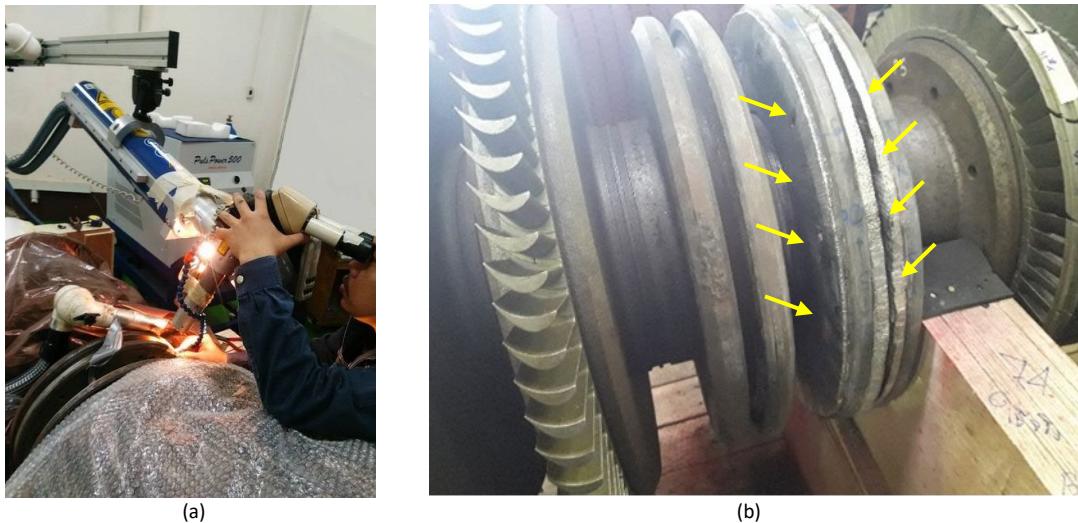
Fig. 7. (a) Laser welding performed on the damaged areas of the rotor disk; (b) As welded surfaces after laser welding

The refurbishment process commenced with machining work on the damaged areas in order to remove cracks on the rubbed surface at which the microstructural change occurred. Subsequently, laser welding was carried out as per welding procedure specifications as shown in Fig. 7. A thermography camera was applied to monitor the temperature around the welded areas as demonstrated in Fig. 8.

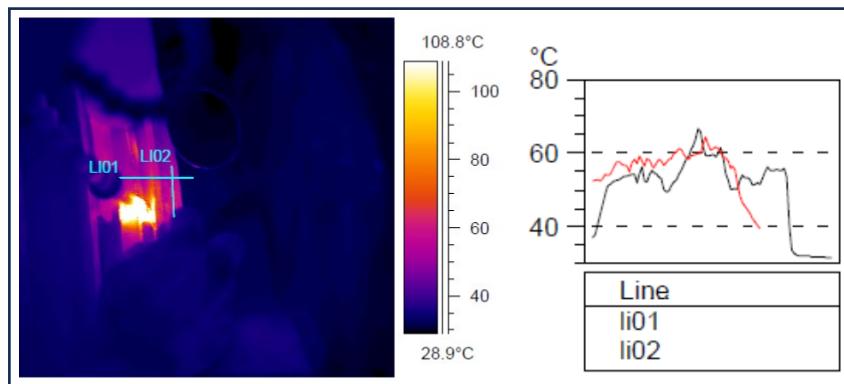
Fig. 8. Monitoring the temperature around the welded areas by thermography camera

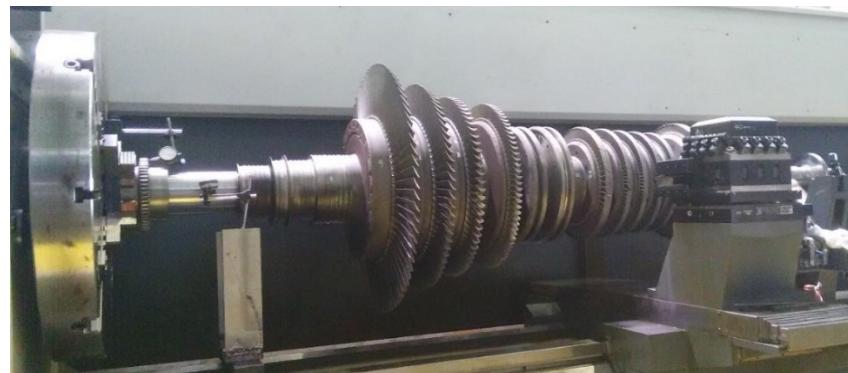
Fig. 9. Machining work after post weld heat treatment

After cooling down to ambient temperature, the rotor was set up on the lathe and machined at the welded areas to original dimensions as shown in Fig. 9. Non-Destructive Testing (NDT) including visual inspection, liquid penetrant testing, and dimension checking were conducted by certified quality control staffs. The new turbine blades were installed in the turbine groove before performing rotor run out and low speed balancing.

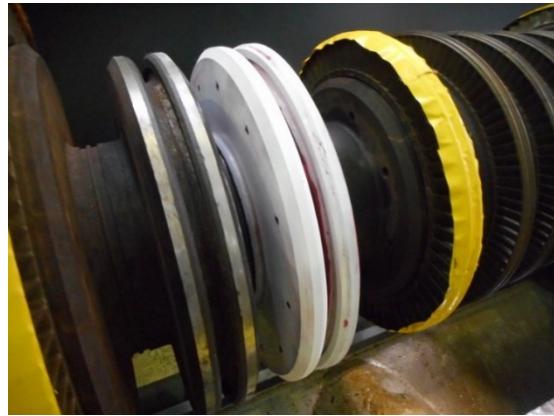
Aside from dimension checking, liquid penetrant testing was undertaken for examining the indications following laser welding. The result confirmed that no cracks were found on the welded areas as shown in Fig. 10. Moreover, the hardness

result of the nickel based superalloy weldment after final machining was reported to be 374 HV in average significantly greater than the values on the tested specimen (238.4 and 248.0 HV) and rotor's base material (274 HV). Due to the effect of work hardening from plastic deformation and strain aging, the high level of hardness after machining superalloys is unavoidable and displays different behavior when compared with the interior surface well agreed with the work indicated in [7].

Fig. 10. Liquid penetrant testing on the welded areas

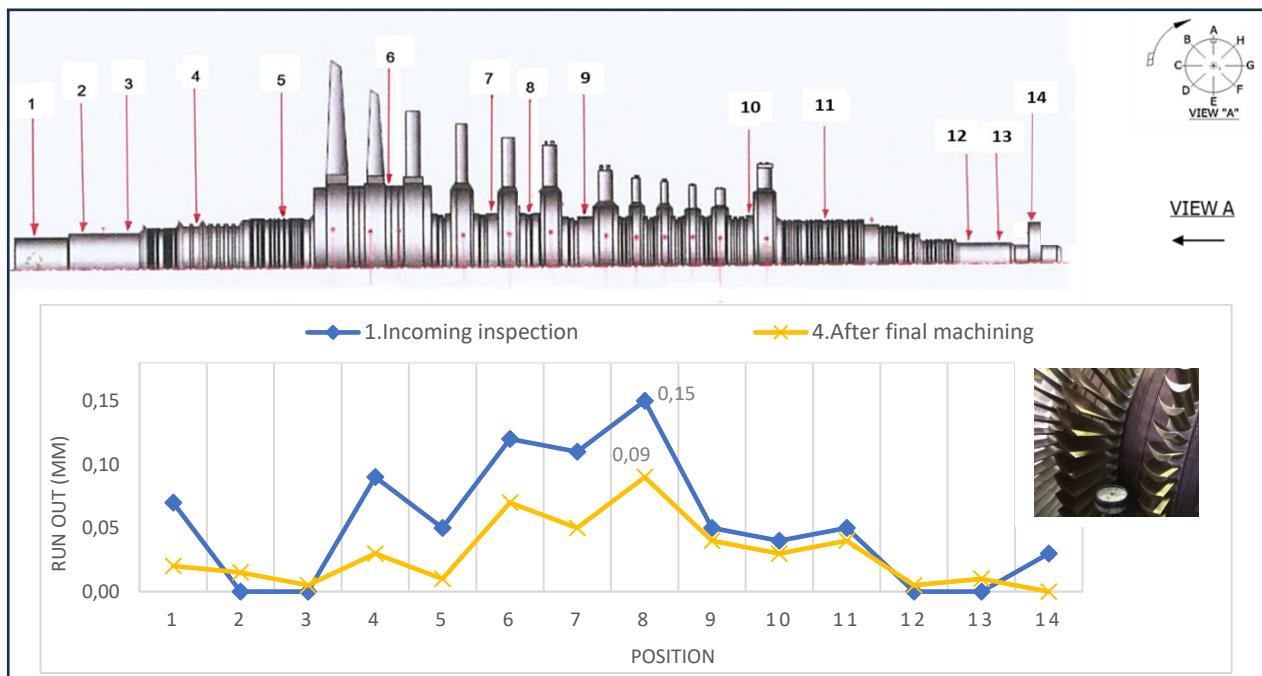
To analyze geometrical unbalance of the rotor, run out measurement is one of the most important indicators to evaluate rotor distortion after refurbishment process especially in welding repair. The rotor was set up for radial run out check using a dial gauge. The maximum values from incoming inspection and after final machining were 0.15 mm and 0.09 mm, respectively as illustrated in Fig. 11. It was obvious that the effect of welding process on rotor distortion in this case was minimal as a result of low heat input. In addition, the run out of the rotor tended to be improved after refurbishment process. This could be concluded that the residual stress causing rotor bow after operation was reduced by applying heat treatment in vertical position.

Fig. 11. Rotor run out results

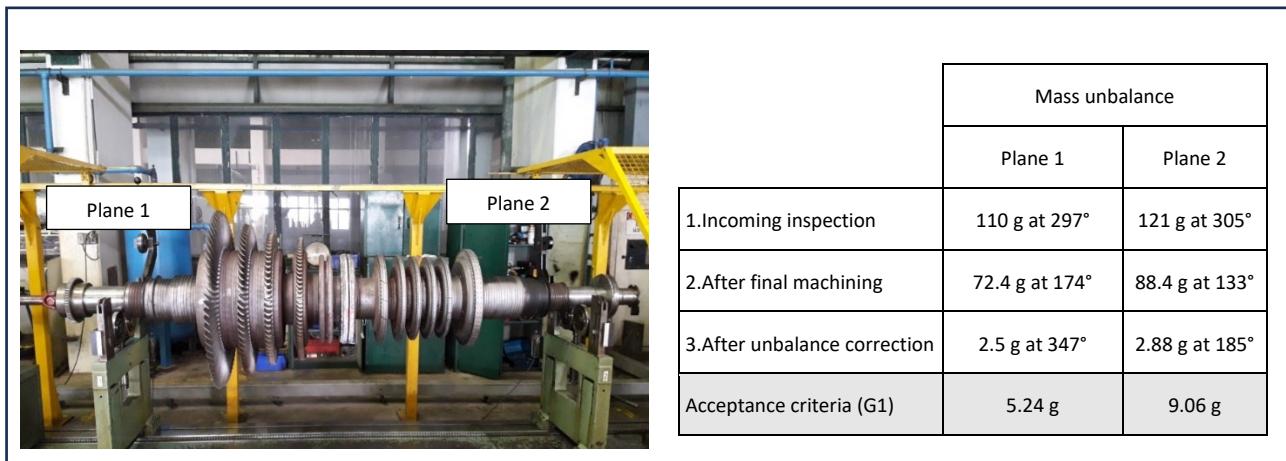
The residual mass unbalance of the rotor for 2 planes was checked on the low speed balancing machine having capacity of 3,200 kg as shown in Fig. 12. for incoming inspection, after final machining and after unbalance correction. This was the crucial process to confirm that the refurbished rotor will run without vibration problems in operating conditions to generate electricity of the power plant. The acceptance criteria of mass unbalance were followed the ISO 1940 Balance quality requirements for rotors in a constant (rigid) state — Part 1: Specification and verification of balance tolerances with the balance quality grade G1 for steam turbines. The results from Fig. 12. illustrated that the values from incoming inspection were significantly greater than the unbalance limits of the acceptance criteria because of the material loss in the damaged areas of the rotor disk from heavy rubbing. After repairing work, the mass unbalance correction by adding weight plugs on the rotor was performed and resulted in the minimal values of 2.5 g at 347° for Plane 1 and 2.88 g at 185° for Plane 2, which were below the acceptance limits.

Fig. 12. Rotor mass unbalance checking and results

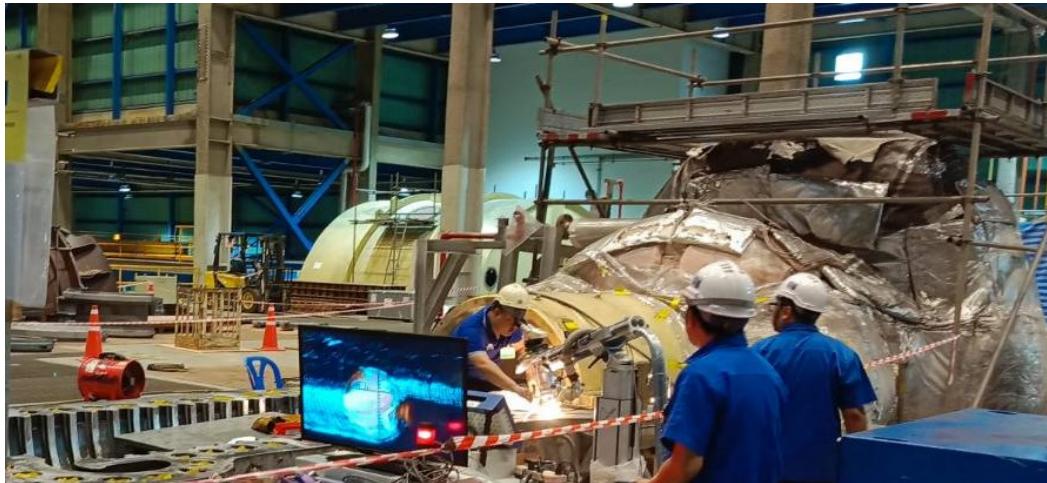
The following project for steam turbine casing repair as shown in Fig. 13. was an outstanding work to figure out how to solve the leakage problem of the contact surfaces between upper and lower casing. In this case, the fiber laser source with a power output of 1,200 W was utilized to overlay the nickel based super alloy on a Cr-Mo steel with the weld thickness of

Fig. 13. Steam turbine casing repair using laser welding

5 mm. After completing welding process, face milling operation was arranged to obtain finish size dimensions of the casings. For NDT, there were no indications examined by liquid penetrant test. The machined surfaces of the casings were investigated using surface roughness measurements. The laser tracker and 3D scanner, coordinate measuring devices, played a significant role in investigating casing geometry. An example of the result for upper casing in Fig. 14. revealed improved flatness and parallelism after reconditioning, enhancing the contact surface between lower and upper casing without leakage issues.

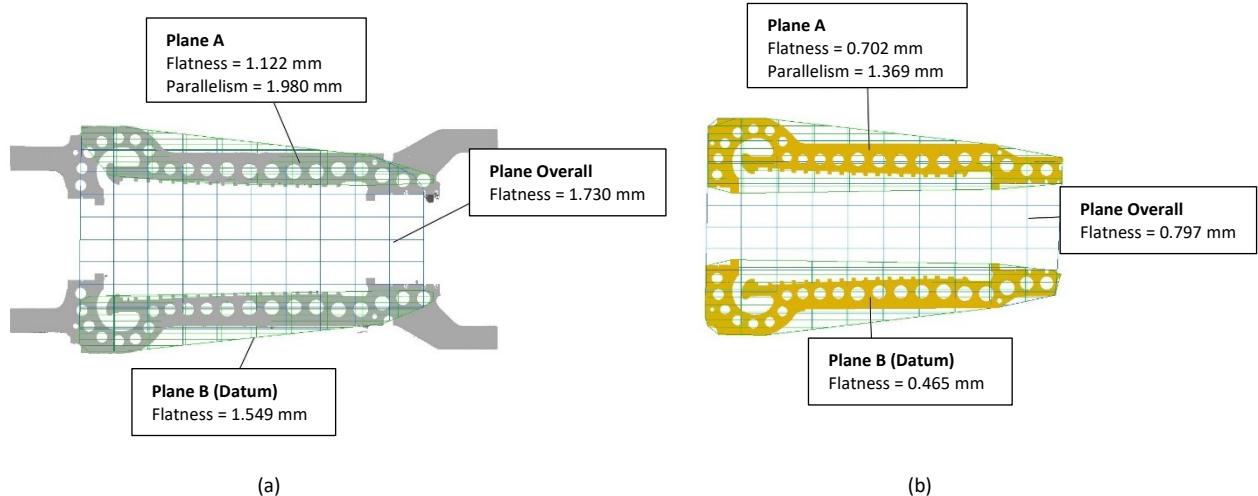
Fig. 14. Flatness and parallelism results for upper casing (a) Before repair; (b) After repair

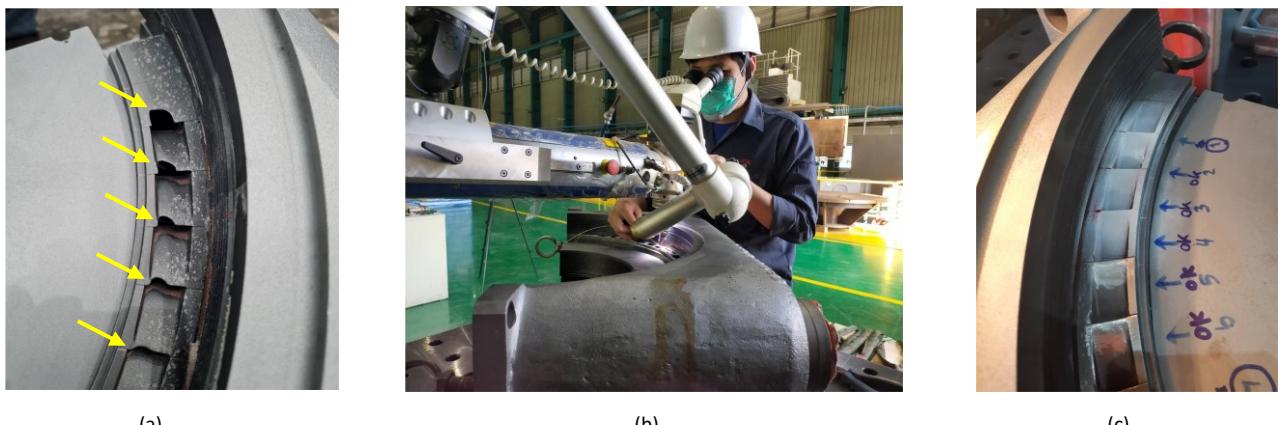
Fig. 15. (a) Eroded and corroded blades of turbine nozzle; (b) Laser welding repair; (c) Repaired blades after grinding and liquid penetrant testing

Another remarkable implementation of laser wire welding involved repairing the stator blades of turbine nozzle by filling up a nickel alloy filler material on martensitic stainless steel blades, restoring surfaces damaged by erosion and corrosion during operation. A 900 W laser welding machine was applied in this case, and the subsequent activities for grinding work along with NDT verification were done without the evidence of cracks on the repaired blades as shown in Fig. 15. The reconditioned part was then assembled in the power plant and run with acceptable vibration and efficiency levels.
