Lasers in Manufacturing Conference 2023

# In-situ defect detection via active laser thermographic testing for PBF-LB/M

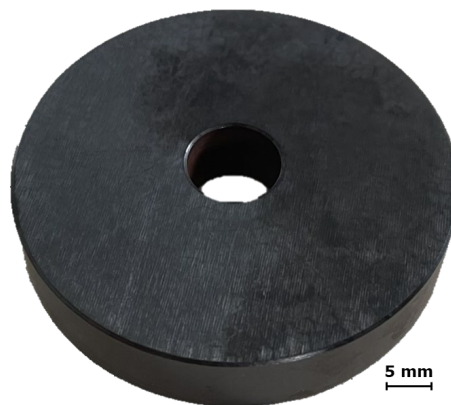
Fig. 2. Investigated surface cracks test specimen.

The specimen is made from 90MnCrV8 stainless steel and has a diameter of 50 mm and a width of 10 mm. It was hardened, pickled, and stress corrosion cracks were induced on its surface. The treatment gave the specimen a dark color. However, as shown in Fig. 2, the surface is not homogeneously colored which indicates inhomogeneous emissivity (and therefore absorptivity) of the specimen surface.

Preliminary thermographic tests were carried out on a reference test specimen for magnetic particle inspection. It was used due to its various surface cracks (width 1 to 10  $\mu\text{m}$  in the tested area). This makes it suitable for active laser thermographic testing via flying spot thermography. It is depicted in Fig. 2.

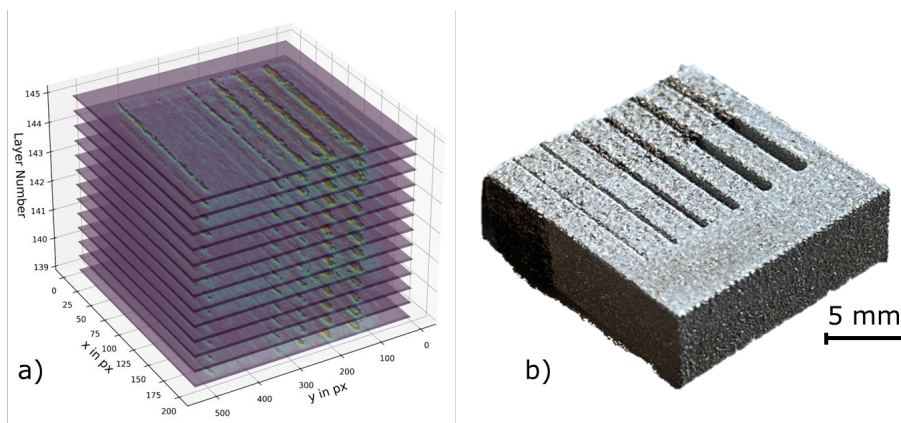
Fig. 6. (a) 3D visualization of the layers during the PBF-LB/M process tested via flying spot thermography; (b) Finished component with visible marks from flying spot thermography.

The flying spot thermography scan was carried out after each manufactured layer. A 3D view of the resulting maximum thermograms is shown in Fig. 6 (a) for the layers 139 to 145. Thus, nondestructive testing can be performed throughout the whole build process if needed. Defects may be found immediately, and appropriate measures may be performed. However, as observable in the image of the finished component (Fig. 6 (b)), the heat input of the thermographic testing still influences the AM component itself. The powder gets sintered inside the notches where testing took place. Furthermore, a slight darkening of the AM component surface is visible, so the flying spot parameters have to be optimized further. However, it is imaginable that an additional heat input may even be beneficial for the component quality, but studies on this aspect are necessary. Nevertheless, the implementation of active laser thermographic testing of each layer during the PBF-LB/M process shows potential for a future with in-situ nondestructive testing for AM.
