Automated inline rewelding processes based on detection of process anomalies during laser deep penetration welding

Abstract

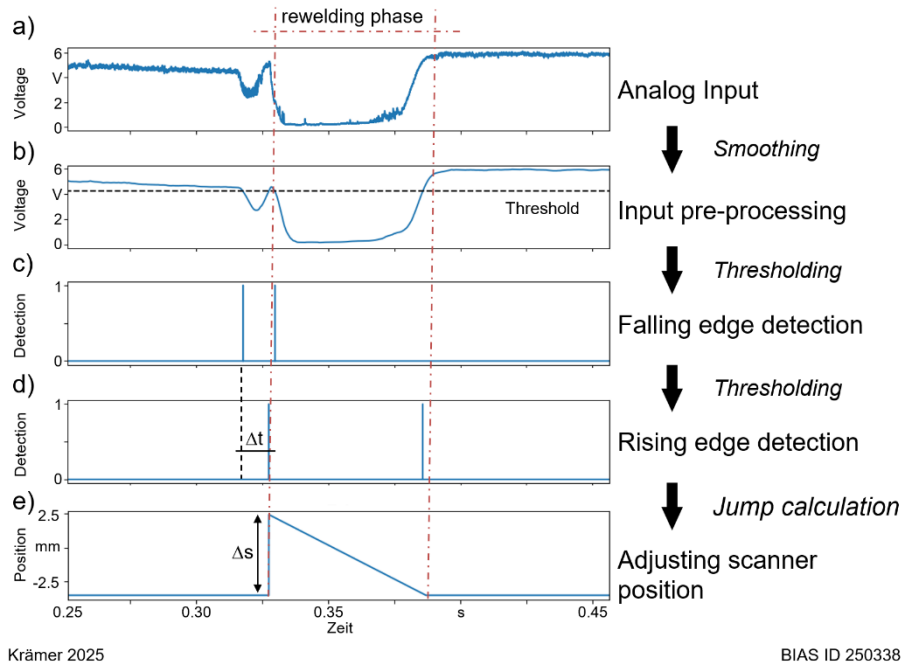
Fig. 3: Data processing and controller intervention with a) analogue pyrometric voltage signal, b) smoothed pyrometric signal, c) negative threshold violation, d) positive threshold violation e) scanner deflection

Based on the findings of the significant improvements on the seam quality by rewelding, the previously described controller system was realized in order to react to detected seam imperfections and demonstrate an in-situ closed loop rewelding approach. In Fig. 3 the corresponding signals of the proof of concept demonstration are displayed.

Fig. 3 a) shows the raw pyrometric analog voltage signal, while Fig. 3 b) shows the smoothed pyrometric signal. A steady decrease in voltage can be observed until the process zone reaches the entrapped wood splinter. Then the signal drops on a short timescale. The violation of the threshold during this drop gets detected by the falling edge detection in Fig. 3 c), while the rising threshold violation detection is displayed in Fig. 3 d). As soon as the signal again rises above the threshold, Δt and subsequently Δs are calculated. The scanner deflects the spot accordingly. The spot deflection in relation to the center point is plotted in Fig. 3 e). The position shifts linearly towards the nominal position due to the constant correction speed. During this rewelding phase, the controller neglects further threshold violations until the nominal position is reached once again. This is necessary as it becomes obvious during the rewelding phase. As the laser spot jumps behind the nominal position, a sudden drop in the pyrometric signal is observed since the process zone is now well behind the measurement spot of the pyrometer, as can be seen in Fig. 4. This results in another falling edge detection as well as a rising edge detection when the process zone again reaches the pyrometric measurement spot. Without this logic of intervention, the controller would deflect the laser spot once more, resulting in a loop of undesired interventions.
